Cause and Prevention of Pinhole Leaks in Gas Poly Pipe Production and Gathering Operations

Dirk Smith, President
Ionix Gas Technologies

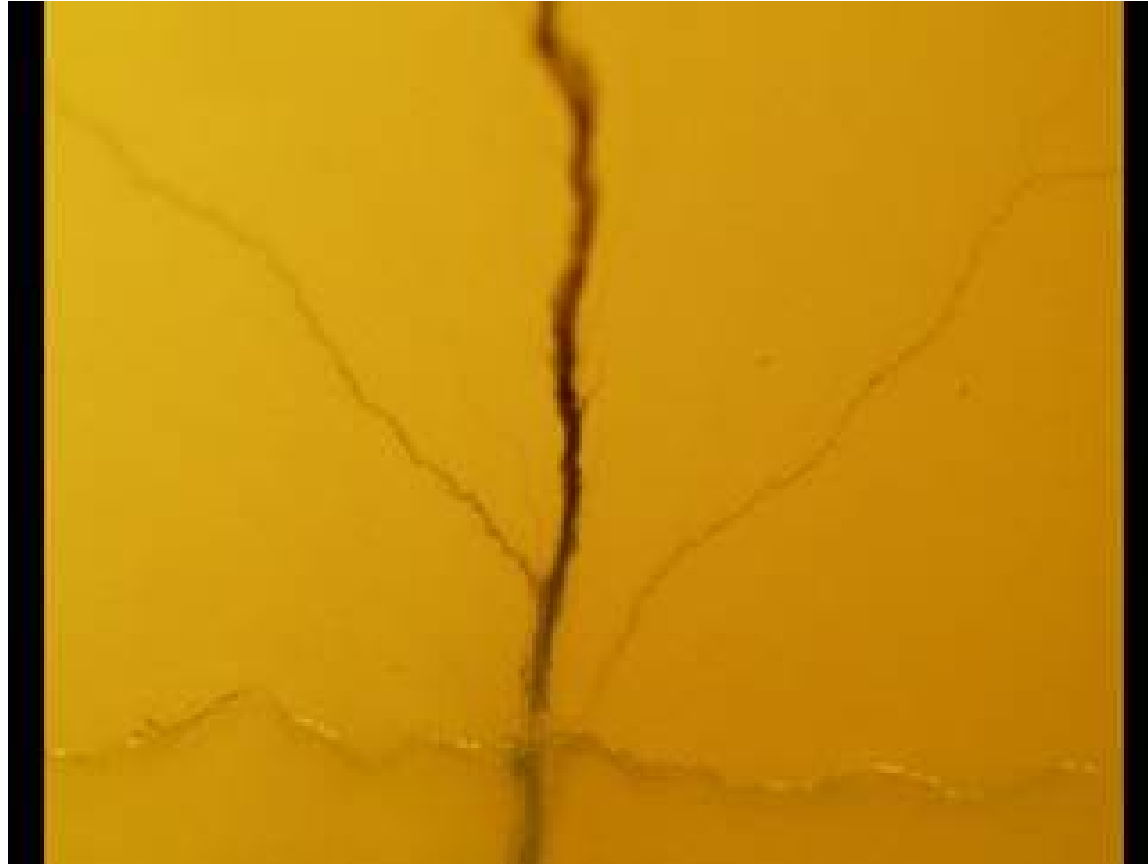
Electron microscope sectional view of electrostatic pinhole

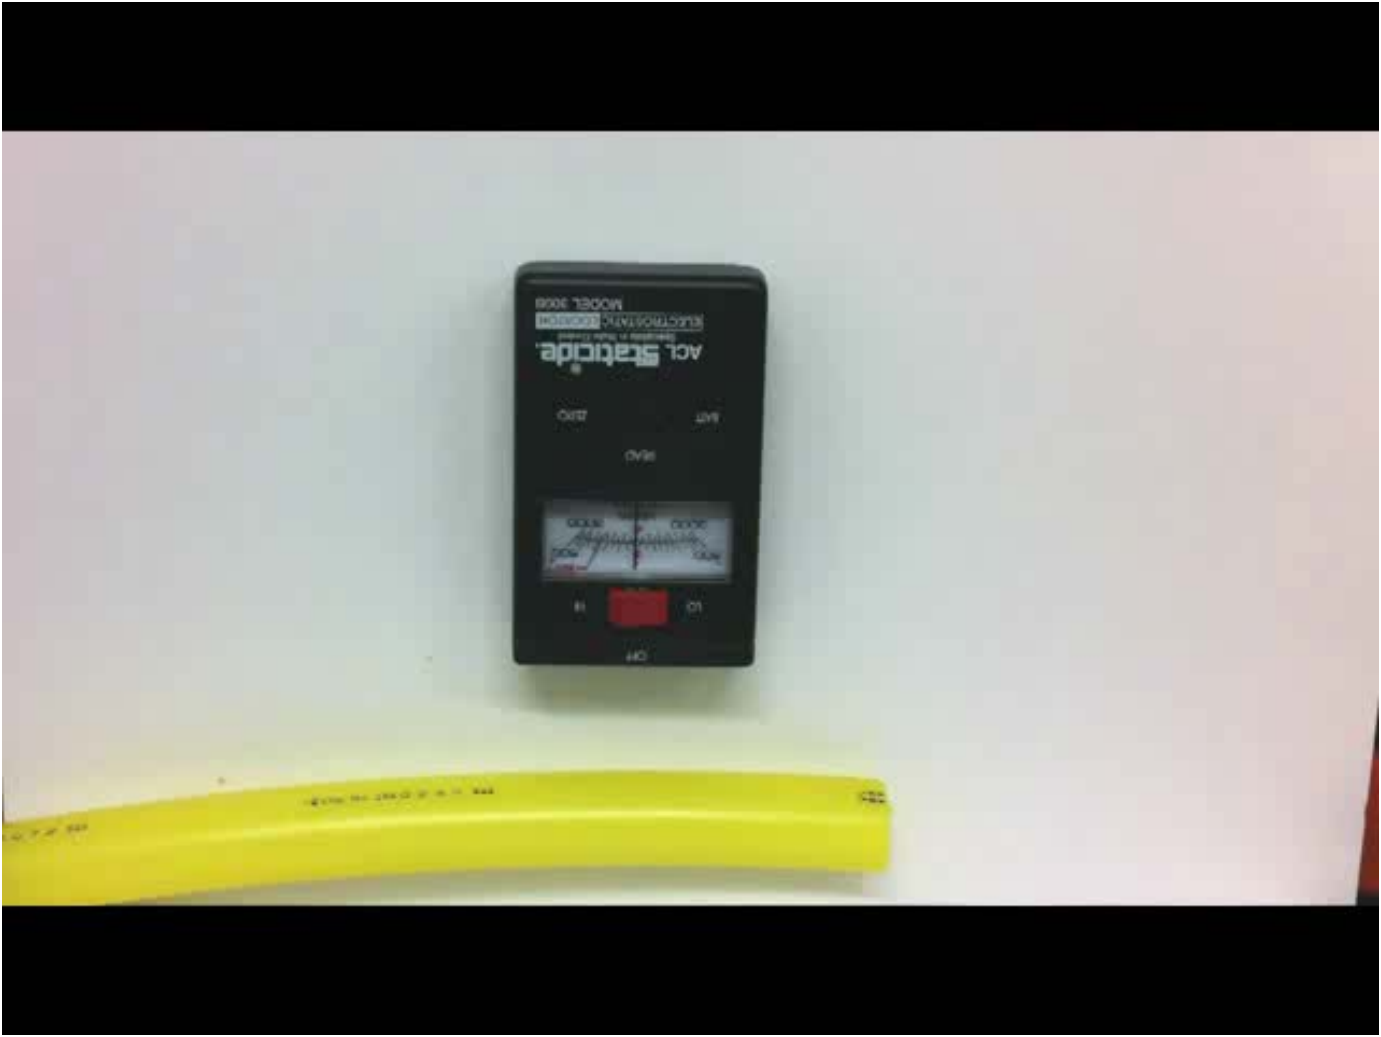
Friction of one electrical insulator rubbing against another displaces electrons which accumulate on one of the surfaces.

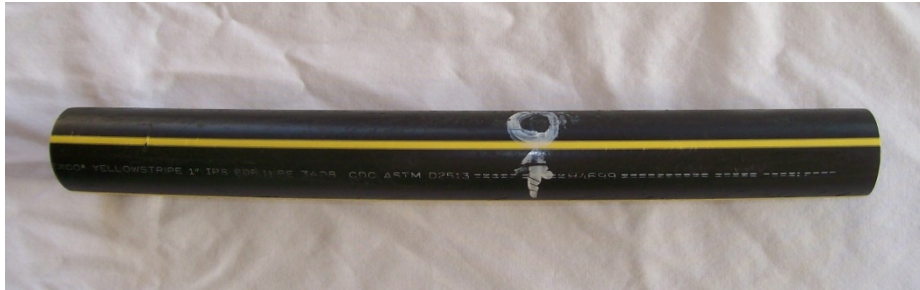
1" Performance MDPE

Performance Pipe Lab conclusion – Static electricity inside pipe causes pinhole

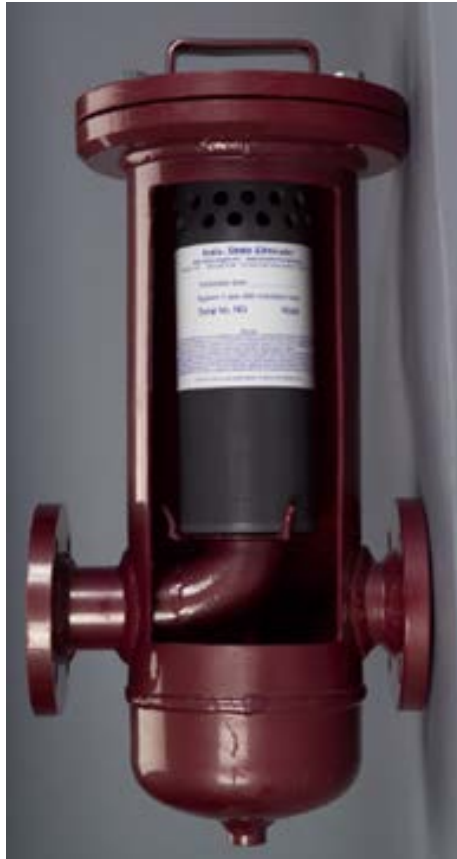
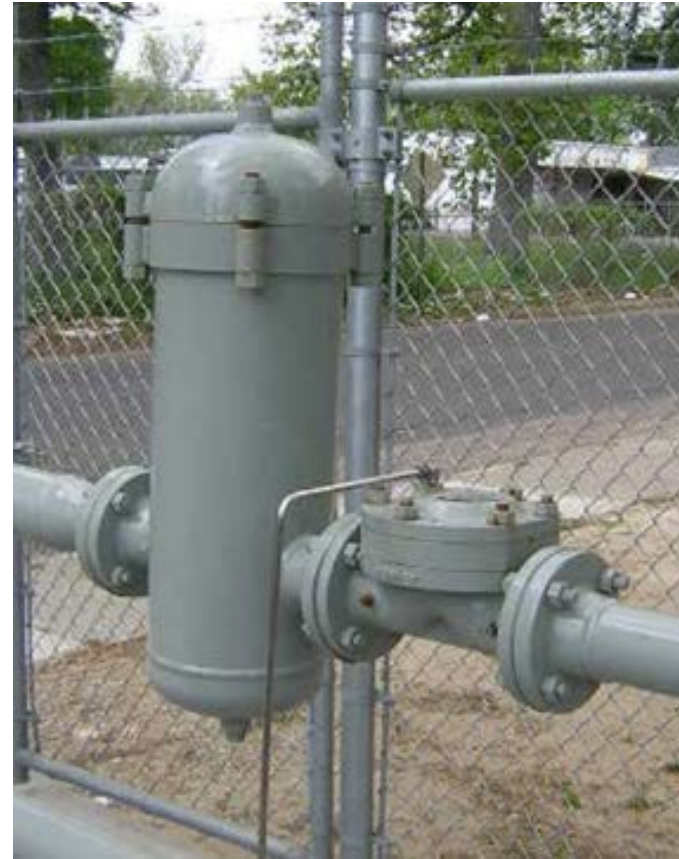
2013/2014 installed Ionix Internal Static Suppression Cartridges at 3" and 4" gate stations (delivery point)

City of Benton Kentucky field test

***After 2013/2014 Ionix Static Suppression Cartridges
installed at 4" and 3" city gates***

Average 11 leaks per year – found in orange, Aldyl, yellow pipe
